**Flood Control Project Maintenance
Levee Inspections**

Fall 2016 Levee Maintenance Deficiency Summary Report

Sacramento River Basin

Reclamation District No. 0900 West Sacramento

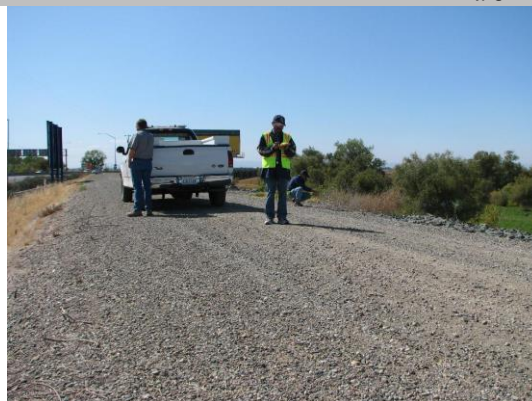
Photo 1 of 2 : UCIP_FA_2016_41825_72725.jpg

Comment Code					
Inspector Comment					
FS_ID:41825					
DS_ID:17862					
EP_NO: 2444					
Repair Type: Non-Urgent					
Crossing Status: Indicator Found					
UCIP Comments: Records show 3 gas lines in general area--unable to confirm alignment and status of crossing. Markers visible in general area are for Kinder Morgan and not the owner listed on permit. Need to contact owner to clarify if crossing is still present and if so determine status of crossing. Need date of last inspection and confirmation that crossing is still in operable condition.					
FIELD_STRUCT_DESC: 16-inch high pressure steel gas line through the levee 3.0 feet below the crown. (Permit No. 2444 & 2893 - PG&E)					
FS Date: 10/5/2009

View of levee crown near marker.

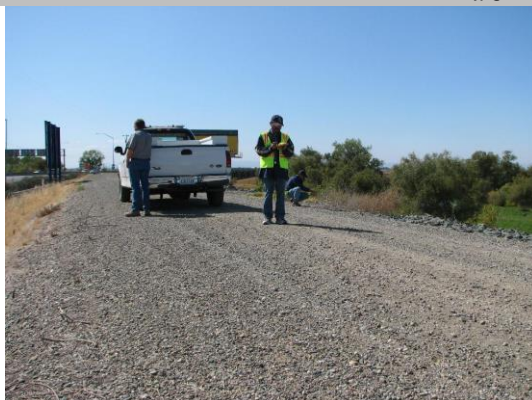
Photo 1 of 2 : UCIP_FA_2016_41826_72722.jpg

Comment Code					
Inspector Comment					
FS_ID:41826 DS_ID:17874 EP_NO: 17739 Repair Type: Non-Urgent Crossing Status: Indicator Found UCIP Comments: Records show 3 gas lines in general area--unable to confirm alignment and status of crossing. Markers visible in general area are for Kinder Morgan and not the owner listed on permit. Need to contact owner to clarify if crossing is still present and if so determine status of crossing. Need date of last inspection and confirmation that crossing is still in operable condition. FIELD_STRUCT_DESC: To install a 20-inch diameter petroleum pipeline across and under (bored) Willow Slough and its west levee, across (trenched) the Yolo bypass, and across and under (bored) Toe drain and east levee. Permit No. 17739. FS Date: 10/5/2009

View of levee crown near marker.

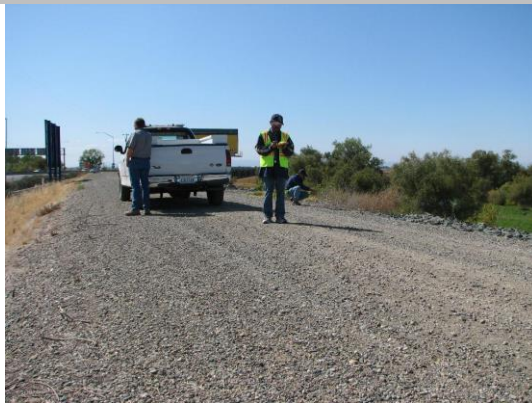
Photo 1 of 2 : UCIP_FA_2016_41824_72728.jpg

FS_ID:41824
DS_ID:17861
EP_NO: 11539
Repair Type: Non-Urgent
Crossing Status: Indicator Found
UCIP Comments: Records show 3 gas lines in general area--unable to confirm alignment and status of crossing. Markers visible in general area are for Kinder Morgan and not the owner listed on permit. Need to contact owner to clarify if crossing is still present and if so determine status of crossing. Need date of last inspection and confirmation that crossing is still in operable condition.
FIELD_STRUCT_DESC: 16-inch steel gas pipeline through the levee 3.5 feet below the crown. (Pending 1/77, App. No. 11539 - PG&E).
FS Date: 10/5/2009

View of levee crown near marker visible on landward shoulder.

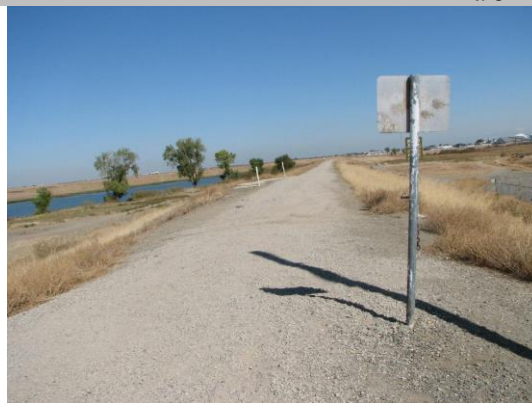
Photo 1 of 2 : UCIP_FA_2016_37770_68626.jpg

LM Start	3.23	Rating **	M	Issue No.	64
LM End	3.23	Issue Type +	En	Location *	LS
Category	Supplemental			GPS Latitude/Longitude	
				Start	End
Item	DWR UCIP Field Study			38.541353 °	38.541353 °
				-121.582202 °	-121.582202 °
DWR ID					
Comment Code					
Inspector Comment					
FS_ID:37770 DS_ID:17885 EP_NO: 17070 Repair Type: Non-Urgent Crossing Status: Found UCIP Comments: Dense vegetation limits the inspector's visibility to identify signs of pipe failure (leaks) along the slope. Recommend removing vegetation along pipe alignment to conduct proper inspection of structure. FIELD_STRUCT_DESC: 1 of 5. 30-inch-diameter steel storm drain pipelines through the left (east) bank levee and a discharge structure in the floodway of the Sacramento River Deep Water Ship Channel. (Permit No. 17070-2000). The pipe depth is 2.0 ft. below the crown. FS Date: 10/5/2009

View of levee crown at crossing.

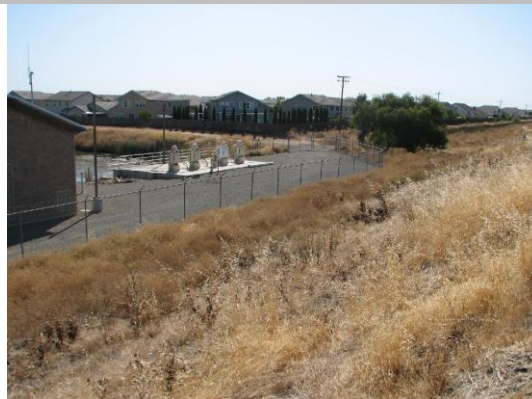
Photo 2 of 2 : UCIP_FA_2016_37770_68625.jpg

Comment Code						
Inspector Comment						
FS_ID:37770						
DS_ID:17885						
EP_NO: 17070						
Repair Type: Non-Urgent						
Crossing Status: Found						
UCIP Comments: Dense vegetation limits the inspector's visibility to identify signs of pipe failure (leaks) along the slope. Recommend removing vegetation along pipe alignment to conduct proper inspection of structure.						
FIELD_STRUCT_DESC: 1 of 5. 30-inch-diameter steel storm drain pipelines through the left (east) bank levee and a discharge structure in the floodway of the Sacramento River Deep Water Ship Channel. (Permit No. 17070-2000). The pipe depth is 2.0 ft. below the crown.						
FS Date: 10/5/2009

Pump station located on waterward side.

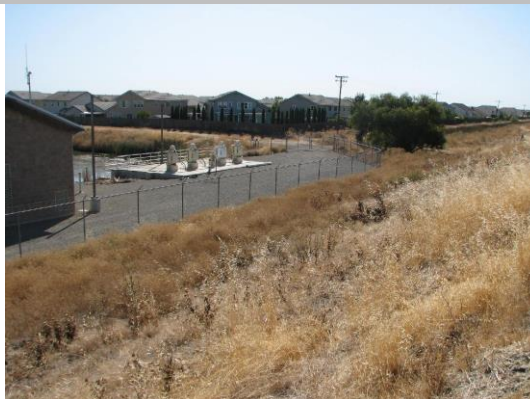
Photo 2 of 2 : UCIP_FA_2016_37766_68619.jpg

Comment Code						
Inspector Comment						
FS_ID:37766						
DS_ID:17876						
EP_NO: 17070						
Repair Type: Non-Urgent						
Crossing Status: Found						
UCIP Comments: Dense vegetation limits the inspector's visibility to identify signs of pipe failure (leaks) along the slope. Recommend removing vegetation along pipe alignment to conduct proper inspection of structure.						
FIELD_STRUCT_DESC: 2 of 5. 30-inch-diameter steel storm drain pipelines through the left (east) bank levee and a discharge structure in the floodway of the Sacramento River Deep Water Ship Channel. (Permit No. 17070-2000). The pipe depth is 2.0 ft. below the crown.						
FS Date: 10/5/2009

Concrete pad with pumps located on landward side.

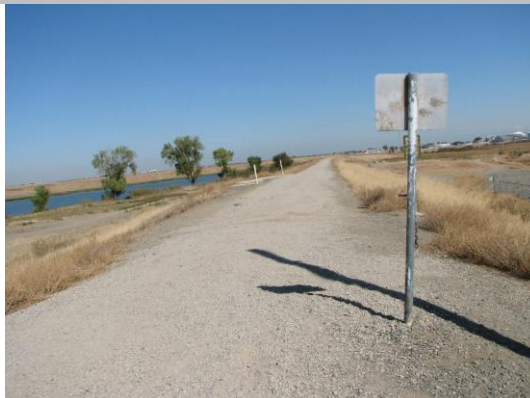
Photo 1 of 2 : UCIP_FA_2016_37778_68650.jpg

Comment Code					
Inspector Comment					
FS_ID:37778					
DS_ID:17888					
EP_NO: 17070					
Repair Type: Non-Urgent					
Crossing Status: Found					
UCIP Comments: Dense vegetation limits the inspector's visibility to identify signs of pipe failure (leaks) along the slope. Recommend removing vegetation along pipe alignment to conduct proper inspection of structure.					
FIELD_STRUCT_DESC: 3 of 5. 12-inch-diameter steel storm drain pipelines through the left (east) bank levee and a discharge structure in the floodway of the Sacramento River Deep Water Ship Channel. (Permit No. 17070-2000). The pipe depth is 2.0 ft. below the crown.					
FS Date: 10/5/2009

View of levee crown at crossing.

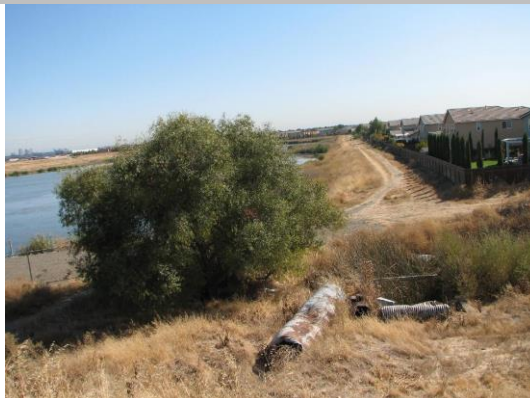
Photo 1 of 2 : UCIP_FA_2016_37785_68693.jpg

LM Start	3.26	Rating **	M	Issue No.	62
LM End	3.26	Issue Type +	En	Location *	LS
Category	Supplemental			GPS Latitude/Longitude	
				Start	End
Item	DWR UCIP Field Study			38.540959 °	38.540959 °
				-121.582224 °	-121.582224 °
DWR ID					
Comment Code					
Inspector Comment					
FS_ID:37785					
DS_ID:17856					
EP_NO: 2721A					
Repair Type: Non-Urgent					
Crossing Status: Found					
UCIP Comments: Need to contact owner--crossing appears to no longer be in use. Abandoned pipe sections visible on landward side and damage to pump station on waterward side.					
FIELD_STRUCT_DESC: 30-inch corrugated metal pipe through the levee 3.0 feet below crown. Pump house and siphon breaker on the waterward slope. (App. No. 2721A - R.D. No. 900) (Station 2)					
FS Date: 10/5/2009

View of pipe sections visible on landward side.

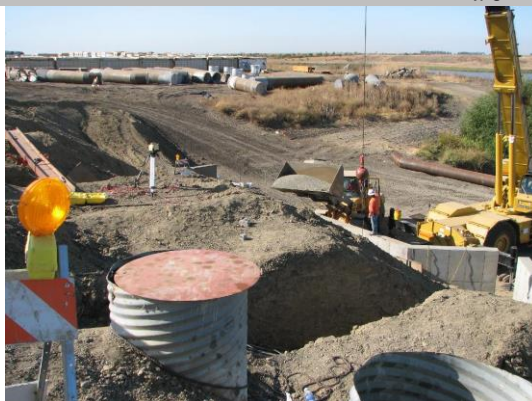
Photo 1 of 2 : UCIP_FA_2016_37890_68941.jpg

Construction of structures in Oct-2009, photo 1 of 3.

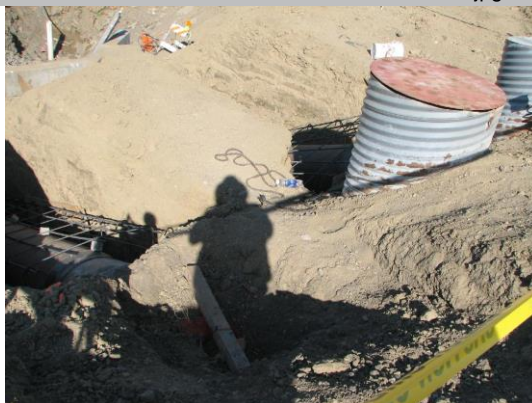
Photo 2 of 2 : UCIP_FA_2016_37890_68940.jpg

Construction of structures in Oct-2009, photo 2 of 3.

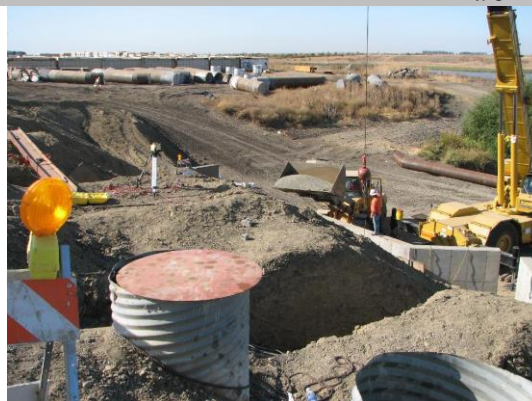
Photo 1 of 2 : UCIP_FA_2016_37892_68947.jpg

Construction of structures in Oct-2009, photo 1 of 3.

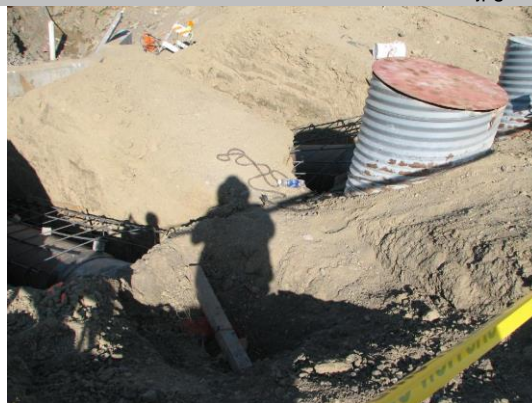
Photo 2 of 2 : UCIP_FA_2016_37892_68946.jpg

Construction of structures in Oct-2009, photo 2 of 3.
